An Uncommon Case Report of a Punctured SVC through a Chemo Port

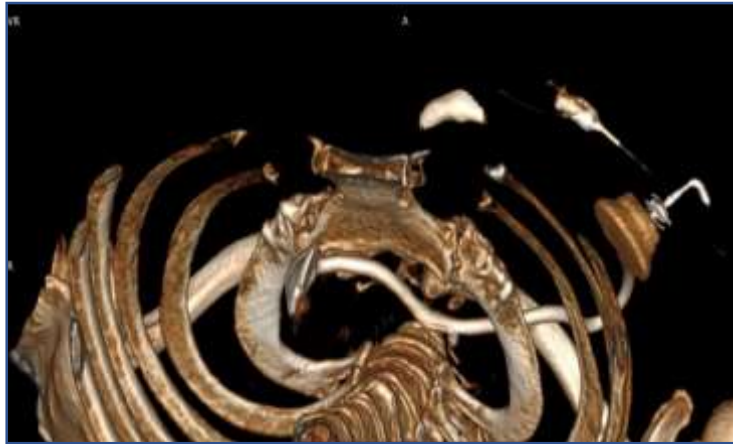
Figure no 01.

Figure no 01,02 and 03 depicts PUNCTURED SVC THROUGH CHEMOPORT

In accordance with the CT scan, the catheter tip was outside the SVC and there was a minor eccentric thrombus along the wall. The distal portion of the port was shown having an extraluminal course in the superior mediastinum with its tip in the precaval area, contacting the anterior wall of the superior vena cava (fig). As the patient was clinically stable, a portogram was recommended. A thin irregular loculated collection of the contrast was found in the anterosuperior mediastinum on the right, abutting the anterior wall of the SVC and the right lateral wall of the ascending aorta, after the injection of 2 cc of iodinated contrast and saline through the port (fig). Even though the port had punctured the SVC, a highly uncommon occurrence, the patient was stable.
